Cayenne V8 Valley Coolant Pipes

How to prevent a major expenditure in pre-2008 V8 Cayennes

BY TONY CALLAS AND TOM PRINE

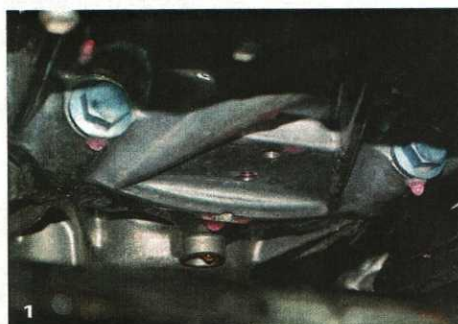
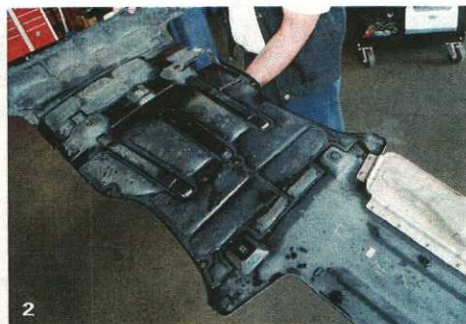
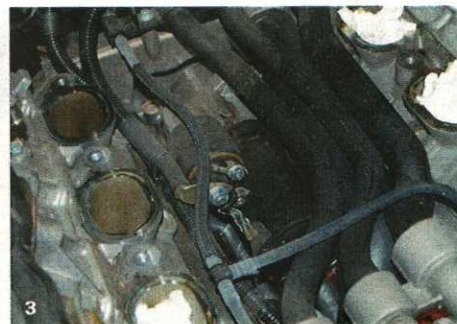
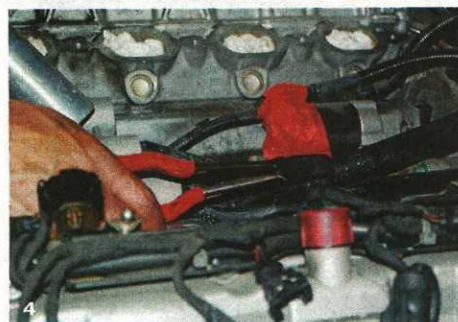
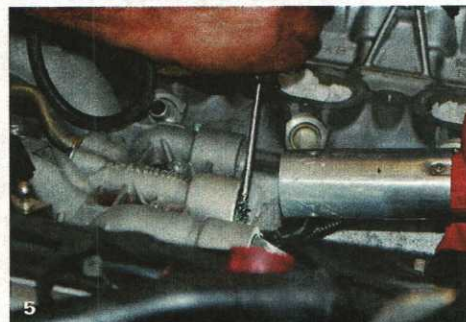
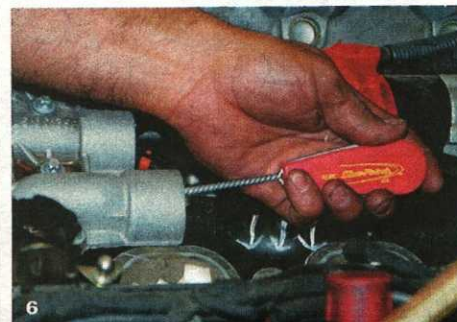
Coolant leaking from rear of V8 and torque converter area (1). Underbody panels also act as catch pans (2). With intake manifold out, coolant in the valley area and wet plastic pipes can be seen (3). Heat gun applied to thermostat housing while pressure is applied to extract the pipe (4). Cleaning out remnants of old plastic pipe and rubber O-rings; heat continues to be applied to help remove old material (5). Using small wire brush to clean out inside bore of thermostat housing (6).

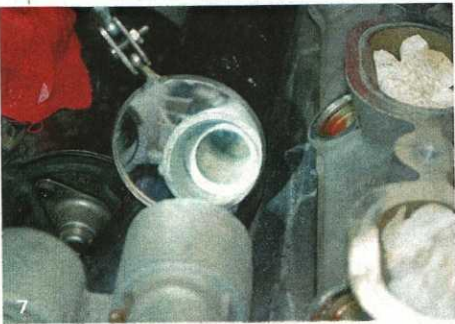
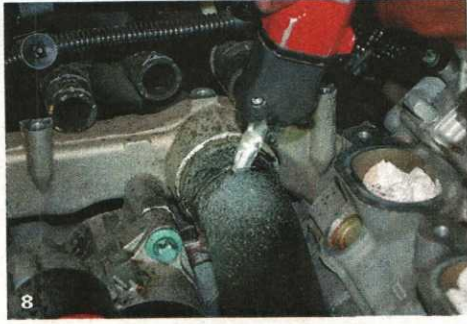
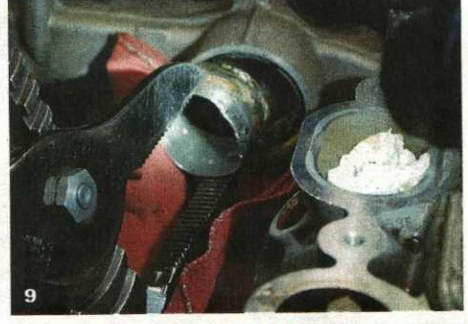
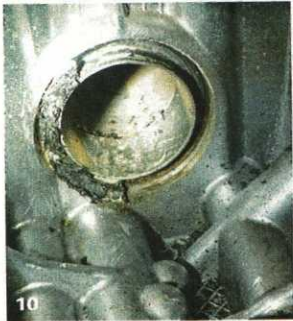
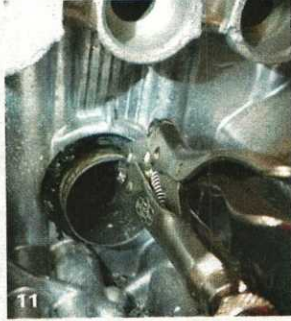
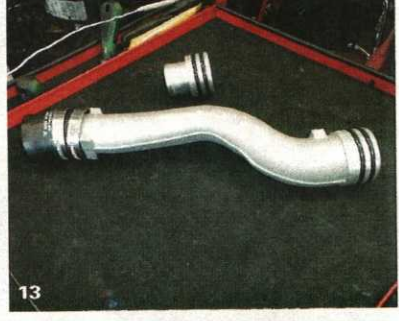
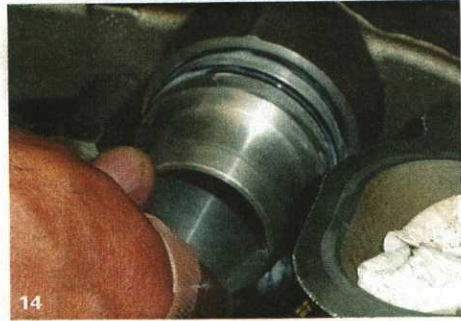
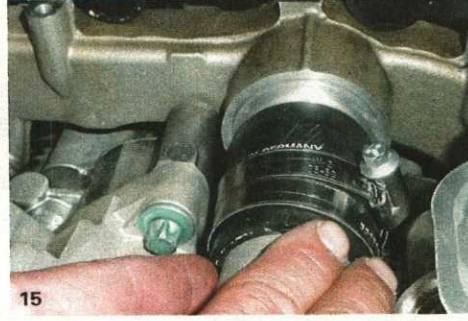
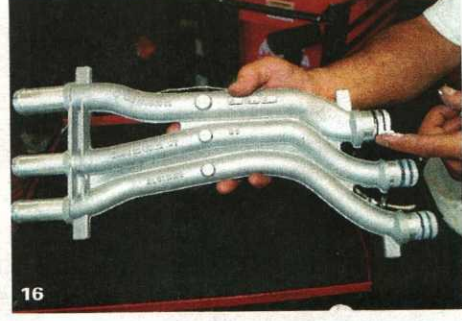
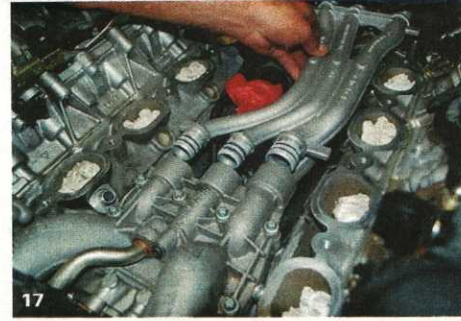
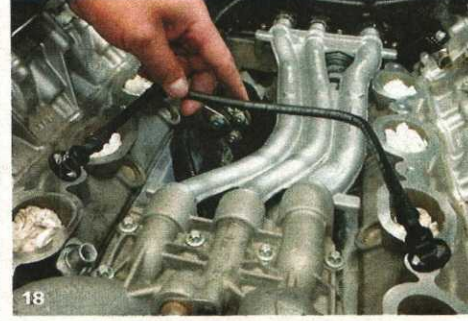
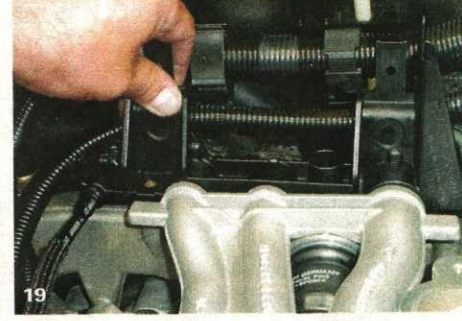
Thoroughly clean all mounting surfaces for new pipes and O-rings (7). Using an air saw, large lower pipe is cut at rear coolant manifold and engine block (8). Channel-Locks help remove metal ring at rear coolant manifold (9). Metal ring can be seen in place at front of engine (10). Vise-Grips attached to metal ring for removal; be sure to clean all inside surfaces and remove all debris from valley area (11). After removal, crack in pipe can be seen; coolant loss would be significant under heat and pressure (12). Lower aluminum coolant pipe replacement parts including pipe, hose, clamps, and adapter with O-rings; note: O-rings are included with pipe, adapter is not (13). Locating aluminum adapter at rear coolant manifold for installation; note Optimal Paste on O-rings (14). With large coolant pipe in place, rubber hose can be moved into place and the hose clamps tightened (15). Upper three-pipe manifold prepared for installation with application of Optimal Paste to O-rings (16). Upper manifold in position, ready for installation (17). Installation of new vent line to coolant reservoir is required in most cases because the old part breaks during removal (18). Installing upper mounting bracket for three-pipe manifold; bracket has provisions for attachment of reservoir vent line as shown. Reinstallation of intake manifold (19).
