Electrical Systems, Part 2

BY TONY CALLAS AND TOM PRINE

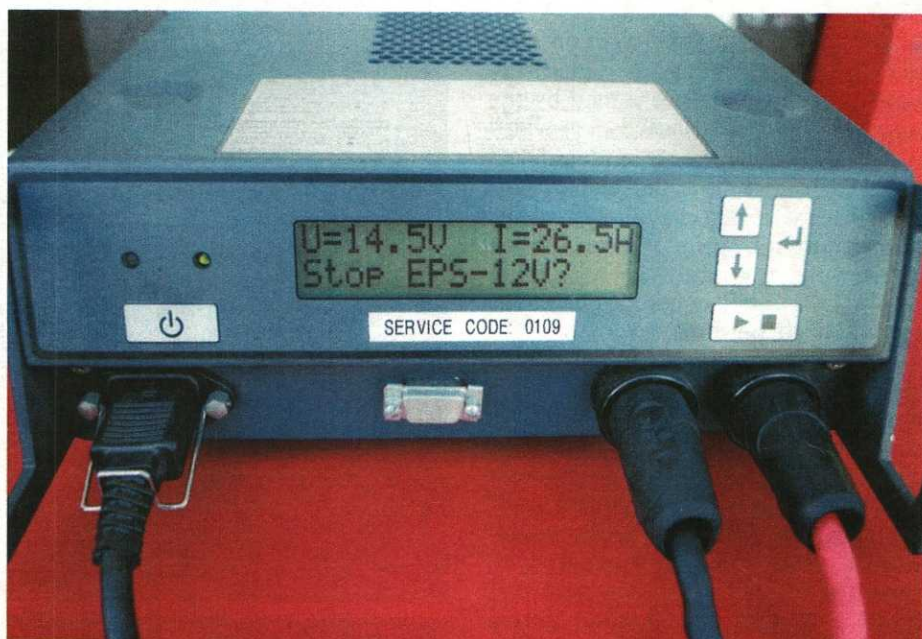
Above: This power supply is applying voltage to the car so that the battery can be disconnected and replaced. Remember: For a battery replacement, do not connect a battery charger or a power supply in the charging mode; if you do, the battery charger may shut off when the battery is disconnected—allowing the erasure of volatile RAM memory. As shown, this power supply is providing power to the vehicle rather than the car battery.

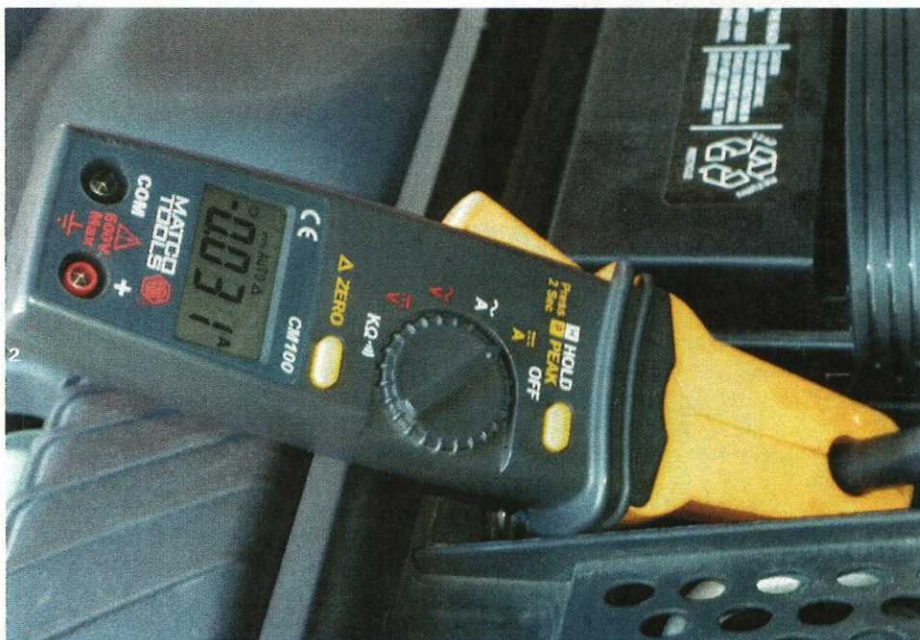
Opposite, top: A good tool to have for finding a parasitic drain is an inductive clamp-on Digital Volt Ohm Meter, or DVOM for short. This can be used for obtaining a reading without having to disconnect any cables. The DVOM shown is connected to a 2002 996 Turbo; the car's Computer Area Network Bus (CAN Bus) system is in sleep mode and the current draw is just 31 milliamperes.

Testing for a "hidden" PD can be a fairly involved process. Having special electronic equipment and a thorough knowledge of a particular Porsche's electrical system is required. With older, simpler Porsches, mechanics used a 12V test light in series with one of the battery cables. If the bulb started glowing, there was some level of current flow. On modern, computer-controlled Porsches, mechanics utilize a high-quality inductive DVOM that clamps around a battery cable (or other power cable) to confirm if a PD is present. This allows a check of the circuit without breaking any electrical contacts.

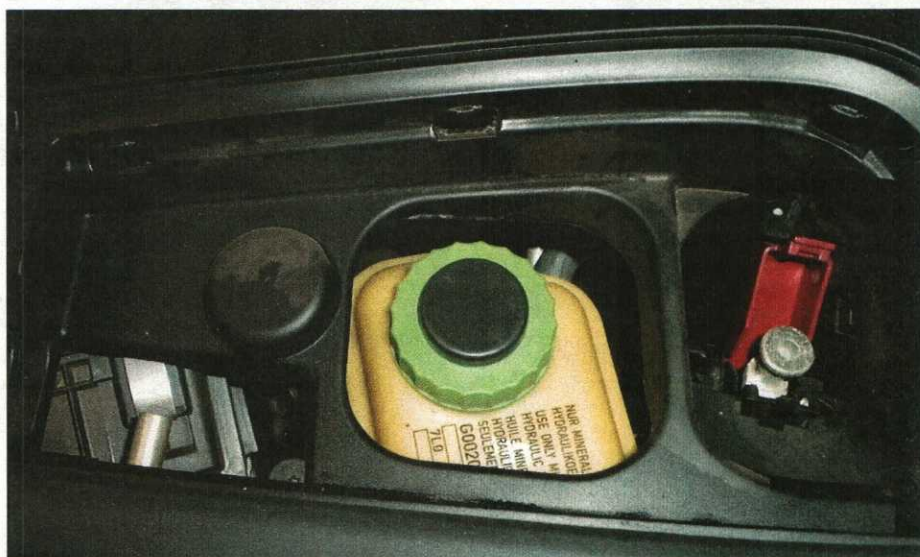
Opposite, middle: These are the jumper posts on a late-model Cayenne S, and they're an ideal location to connect bridged power from a power supply while changing a battery. Note that the posts are on either side of the power-steering fluid reservoir.

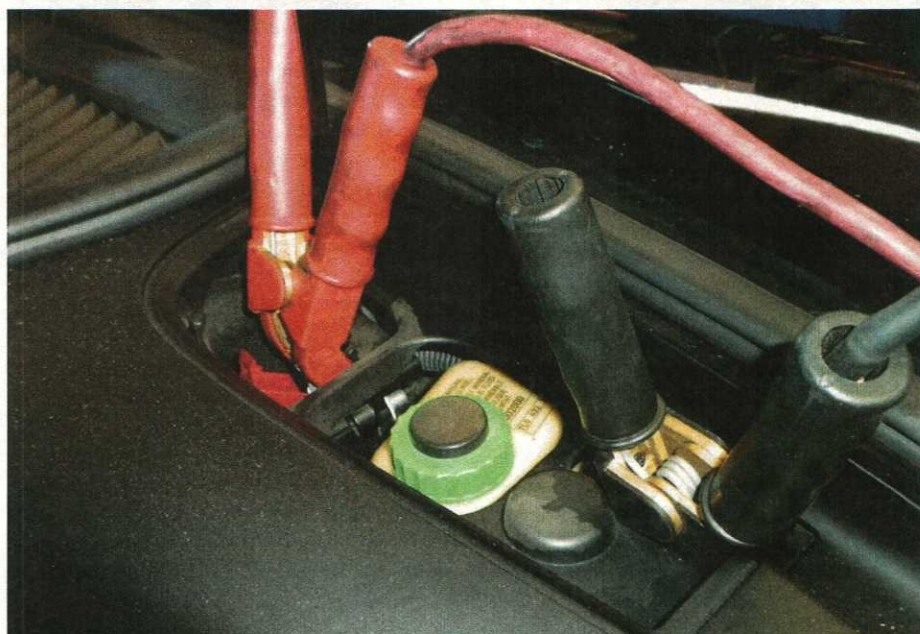
Opposite, bottom: The power supply cables are connected; this is on the driver's side, between the engine and the fender.
