Pre-purchase Inspection, Part III

The physical inspection

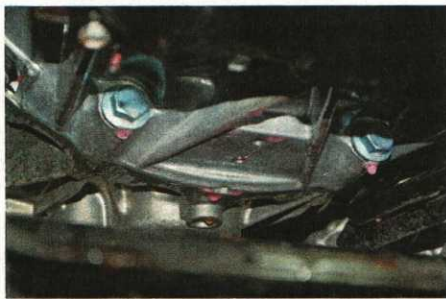
Clockwise from top left: Coolant leak from rear of Cayenne V8 and Tiptronic's torque converter area is sure sign of failed coolant pipes. Metallic fragments found in M96/996 oil filter. Worn M96 water pump. Manometer tests for crankcase vacuum; high reading indicates failing M96 air/oil separator.
