# Tire Pressure Monitoring, Part 2

BY TONY CALLAS AND TOM PRINE

This *Tech Forum*, then, will examine Porsche's latest take on RDK.

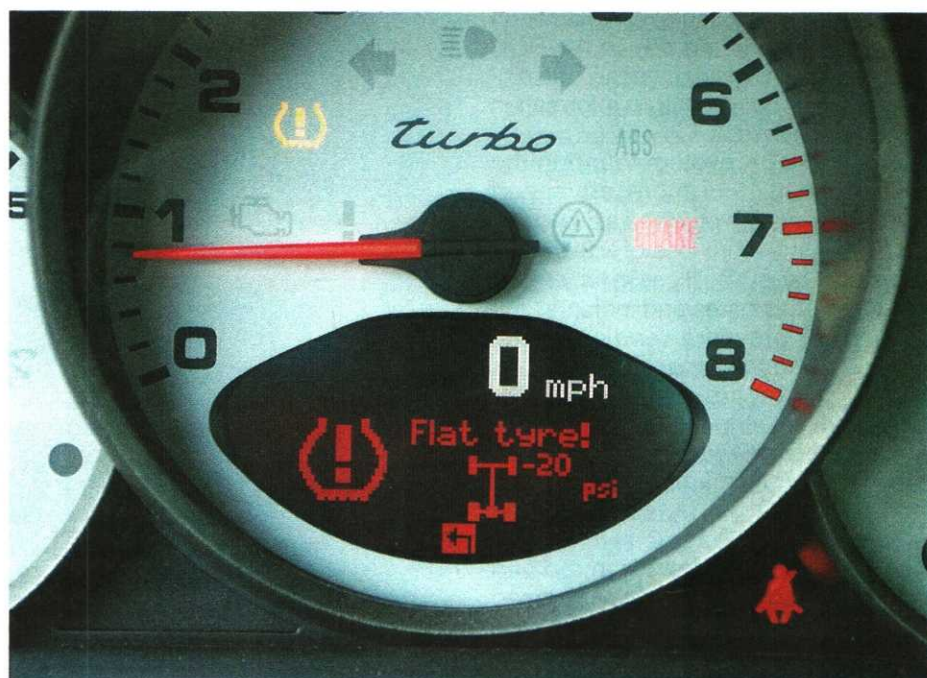
While the car was stationary, we induced a Stage 2 warning—as seen on this 997 Turbo's central information screen. The TPMS alert symbol with its exclamation point is on, as well.

Like the RDK system found in the 959 and 928, this more advanced RDK/TPMS system provides a two-stage warning. A pressure loss of 2.9–5.8 psi triggers a Stage 1 notification, where the pictogram illuminates and indicates the internal air pressure reading of the affected tire in real time. In the event of a Stage 1 warning, Porsche recommends drivers stop at the next suitable opportunity to correct the pressure loss. A loss greater than 5.8 psi (or a loss of more than 2.9 psi in less than one minute) triggers a Stage 2 alert, causing the pictogram to illuminate in red and indicate that the affected tire is going flat. In a Stage 2 warning, Porsche says that the driver should reduce speed and stop immediately to inspect the tire.

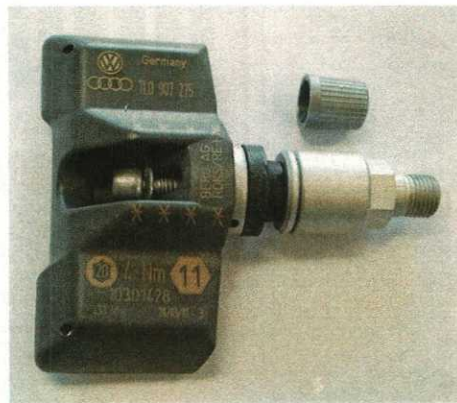
**TOP LEFT:** Close-up view of wheel sensor and valve stem shows how valve stem and sensor attach with a thread-locking screw. Valve stem mounts through wheel with black gasket sealing against inside of wheel rim. Lower left corner of the wheel sensor has a reference to 433 MHz. **TOP RIGHT:** 2008 wheel sensor, Porsche part number 997.606.021.01; a quarter provides a sense of sensor's size. **ABOVE:** 433 MHz receiving antenna next to a quarter; one is mounted at each corner of the car and hidden by the wheel liner. **LEFT:** Making a choice here starts the wheel sensor learning process.

The wheel sensor's lithium battery has an expected useful life of five to ten years, with seven years considered the average. Porsches built for sale in North and South America or Europe utilize wheel sensors that transmit at a radio frequency of 433 MHz, while Porsches built for Asia or Africa utilize 315 MHz. Note: System components with one frequency range are not compatible with those using the other frequency.
